TMS320C6201 SILICON ERRATA

The following is a list of problems on TMS320C6201 2.1 silicon or any lower revision. TI creates a new document revision when a new silicon bug is discovered. However, TI does NOT update previously edited files. For example, if you have silicon revision 1.0 and the latest silicon revision is 2.1, you should look at the latest silicon errata for 2.1, as it will also contain any problems found in silicon version 1.0.

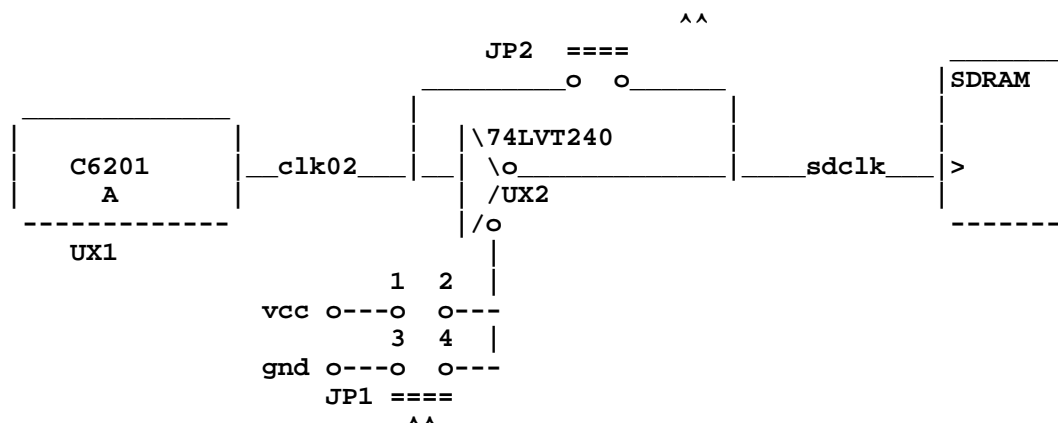
This problem is caused by a skew of CLKOUT2 relative to all of the SDRAM control signals. The SDRAM will not operate properly without a fix involving external components.

UX1: DSP

UX2: Inverting Buffer (delays: min=1 ns, nom=2.9ns, and max=4.1ns)

WORK-AROUND: Below is description of what is being done on the TI test card to overcome the CLKOUT2 skew. The jumpers will allow the same circuit to still be used with the upcoming revisions of the C6201 that will have this problem corrected.
