**RM03**

DISK DRIVE

PROCESSOR TYPE 10, 11, VAX

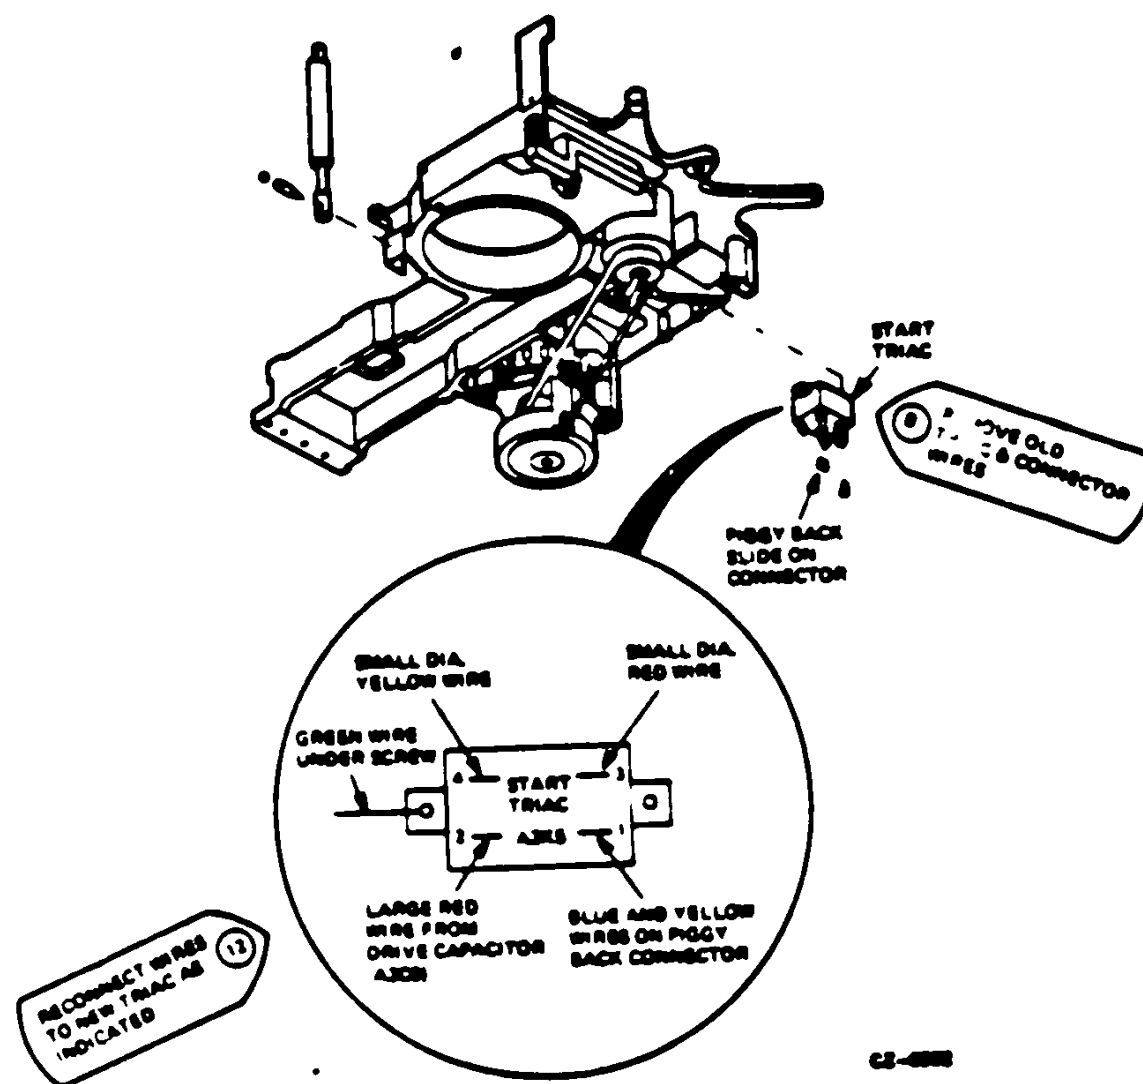
Figure 2 Start Triac A3K5

Failure/Symptoms: Possible start relay failure due to peak inverse voltages in excess of device rating.

This FCO replaces the existing 600 vclt A3K5 Start Triac (CDC P/N 94376501) with an 800 vclt Start Triac (CDC P/N 94376503)

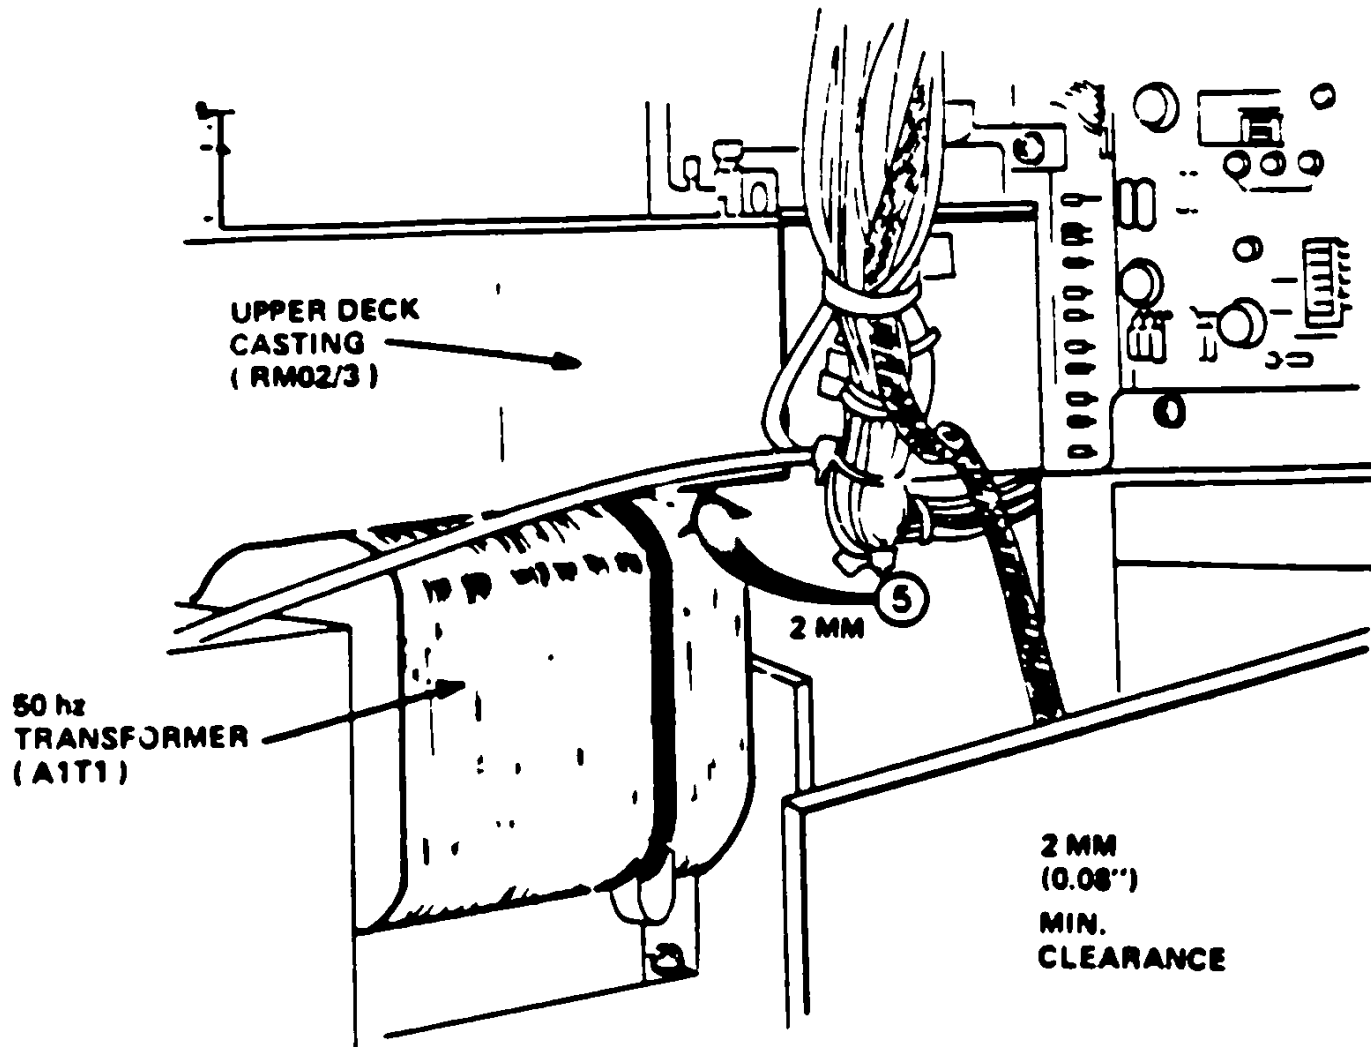
FIGURE 3

**Problem/Symptoms:** Transformer (A171) may come in contact with the upper deck plate assembly (when raised or lowered); resulting in damage to the transformer winding insulation and/or shorting of the transformer windings to the chassis.

7. Carefully examine the insulation on both sides of the transformer (transformer windings insulation) for any signs of physical damage (ie: punctures, tears, scratches, indentations, etc.).

\* **IF PHYSICAL DAMAGE HAS OCCURRED THIS WILL REQUIRE REPLACEMENT** \*  
\* **OF THE TRANSFORMER. GO TO SECTION 2 FOR TRANSFORMER REPLACEMENT** \*  
\* **PROCEDURES.** \*  
\*\*\*\*\*

8. If there is no physical damage to the AC power transformer winding insulation, check to ensure that the required clearance between the AC power transformer winding insulation and the upper deck plate assembly is 2mm (.08 inches).

9. With the deck in its lowered position, check to be sure that there is a minimum clearance of 2mm (.08 inches), between both the left and right side of the AC power transformer winding insulation and any part of the upper deck plate assembly. The critical areas of clearance are noted by the arrows labeled with no. 5 in FIGURE 3. A flashlight and feeler gauge may be required. The side of the transformer closest to the power supply assembly, see FIGURE 4, can be observed by looking through the hole in the rear of the positioner (ARROW 3, FIGURE 1) and applying sufficient light (with a flashlight) as shown by ARROW 4 in FIGURE 1. Assure that there are no pinched wire harnesses and no chance of damage due to contact between the transformer assembly and the upper deck chassis or other surrounding components.

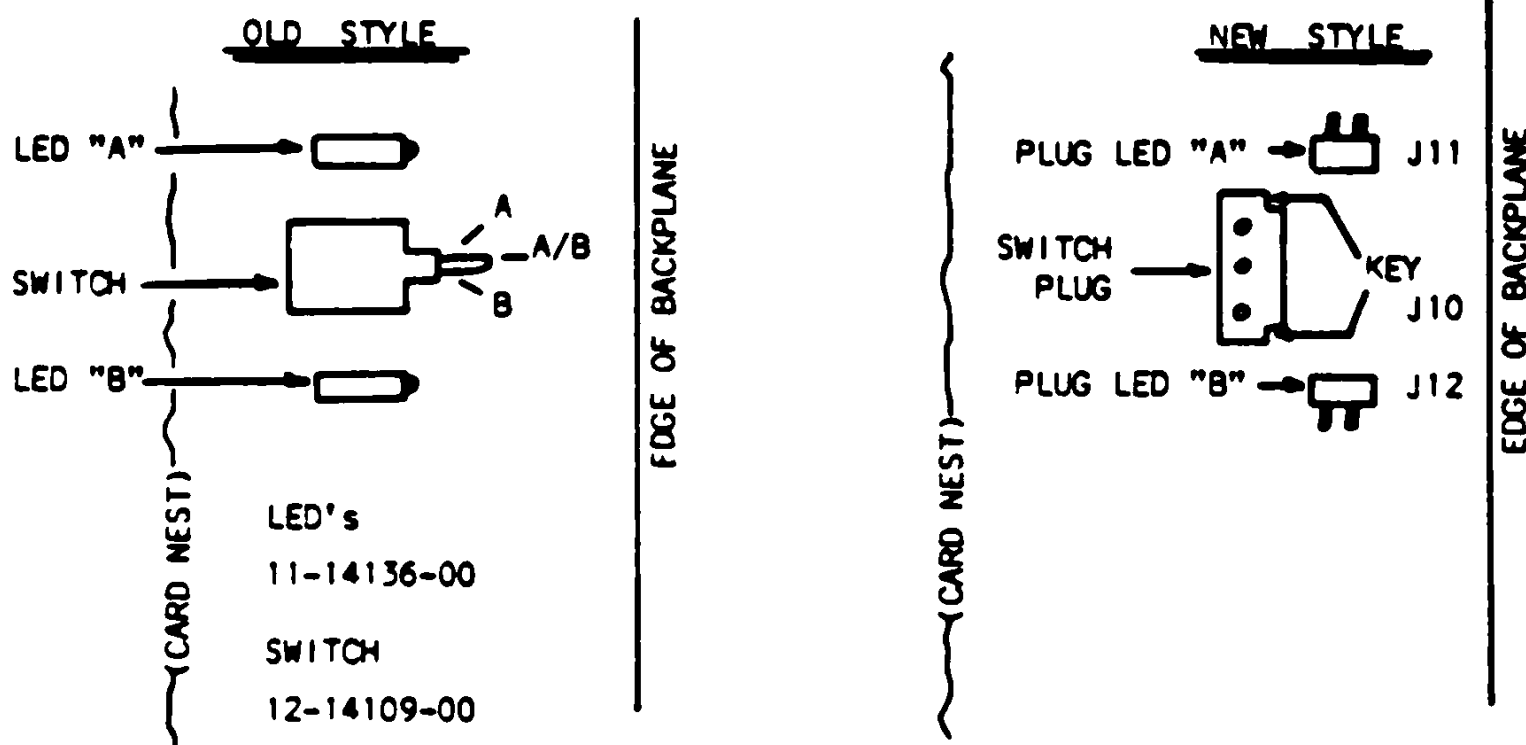
Ensure that the center plug has the keyed side towards the edge of the backplane, away from the card nest as shown below.

If the keyed part of the switch plug is facing the wrong way (towards the card nest) unsolder the plug and reorientate it correctly.

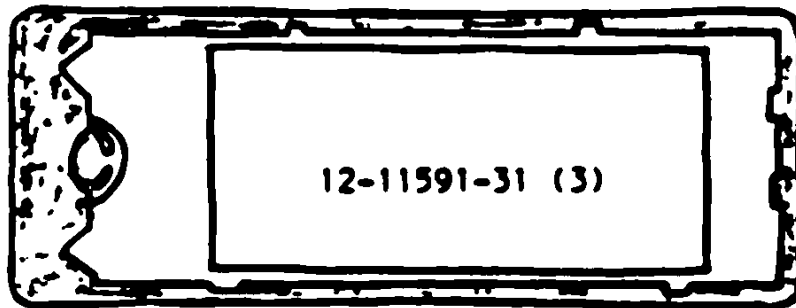
No  
Slots

GOOD

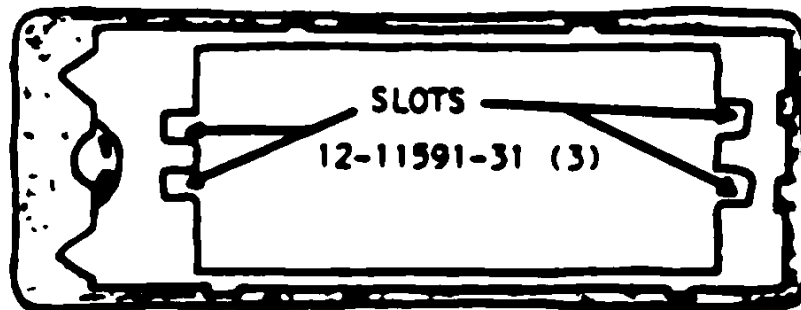
Slots  
NO RIBS

BAD

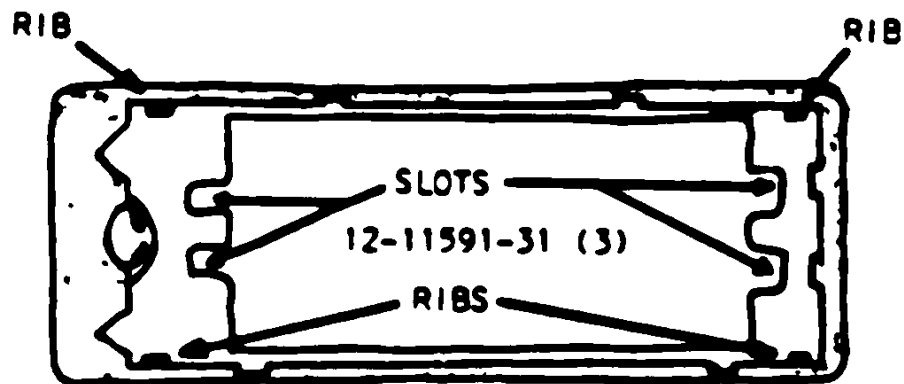
Slots  
&  
RIBS

GOOD

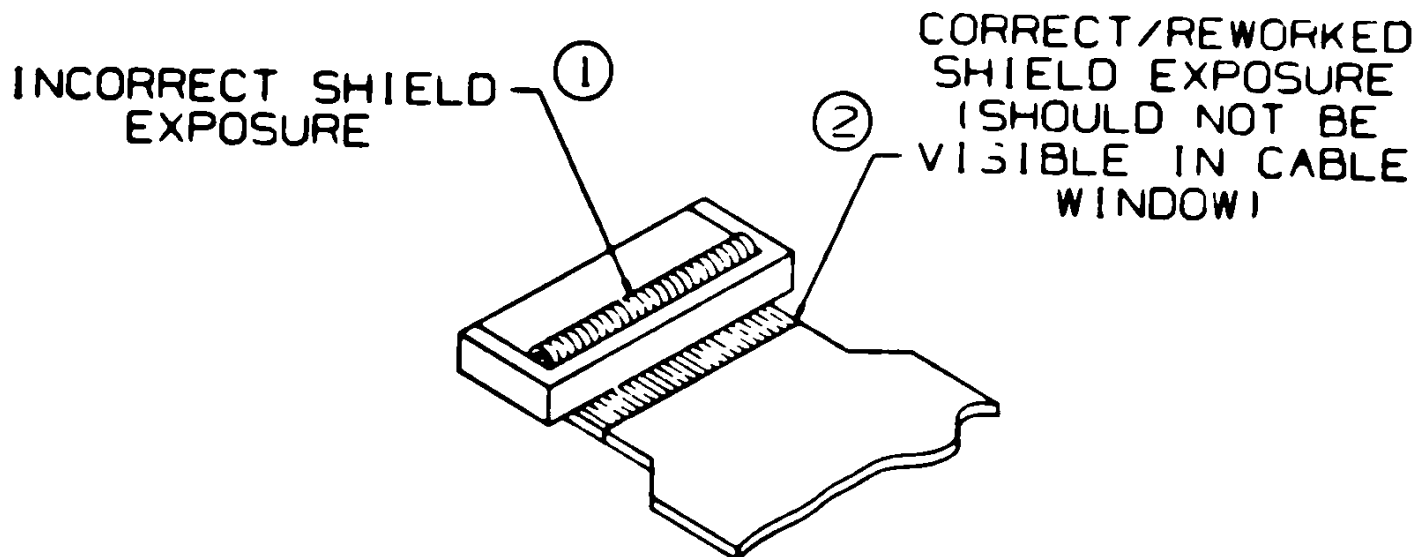
The new FCC shielded A/B cable (p/n 70-19688-15) may cause shorting to the RM05 MBA. Specifically, the end of the 26-pin "B" cable that plugs into J1 of the M7687 module in the MBA, may have "exposed" shielded braid within the cable "window" of the berg connector as shown by area # 1 below.

Cables with exposed shield in this area (#1) can cause shorting of etches on the M7687 when installed. These cables should NOT be reworked in the Field as cable damage could result. Covering the exposed area with tape is also NOT acceptable since you will only be prolonging the problem. You may tape the exposed braid on an existing cable ONLY AS AN INTERIM TO REPLACEMENT. The best solution is replacement of the cable with a reworked Rev "A" cable.

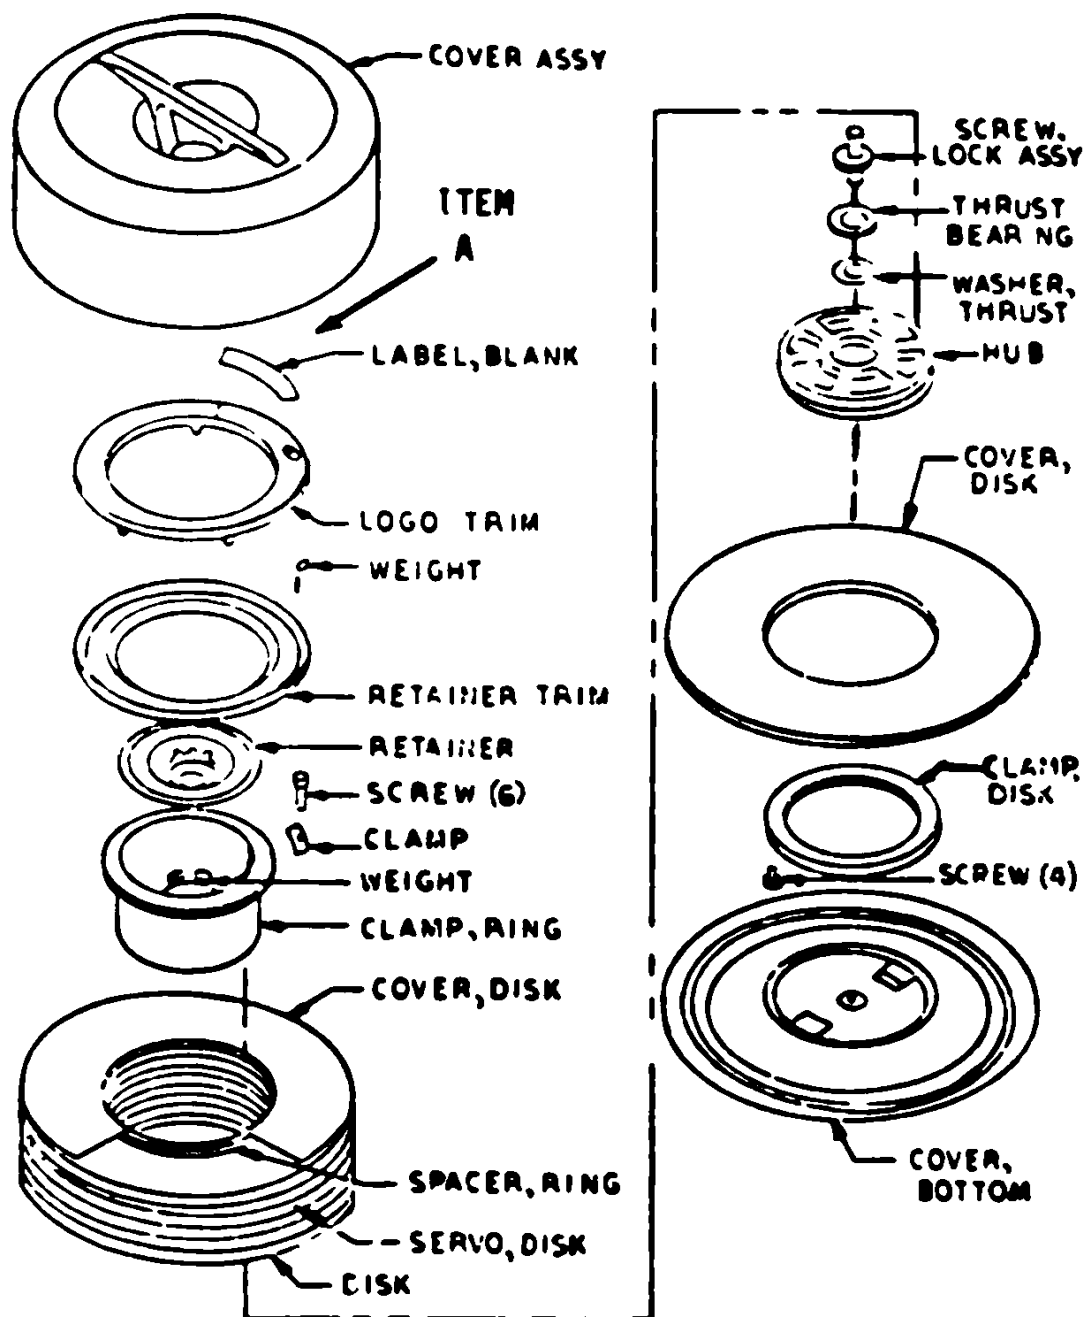
FIG 1, DISK PACK COMPONENTS

An ECO is being written to have these plastic labels excluded from all future packs.
