**RM03**

DISK DRIVE

PROCESSOR TYPE 10, 11, VAX

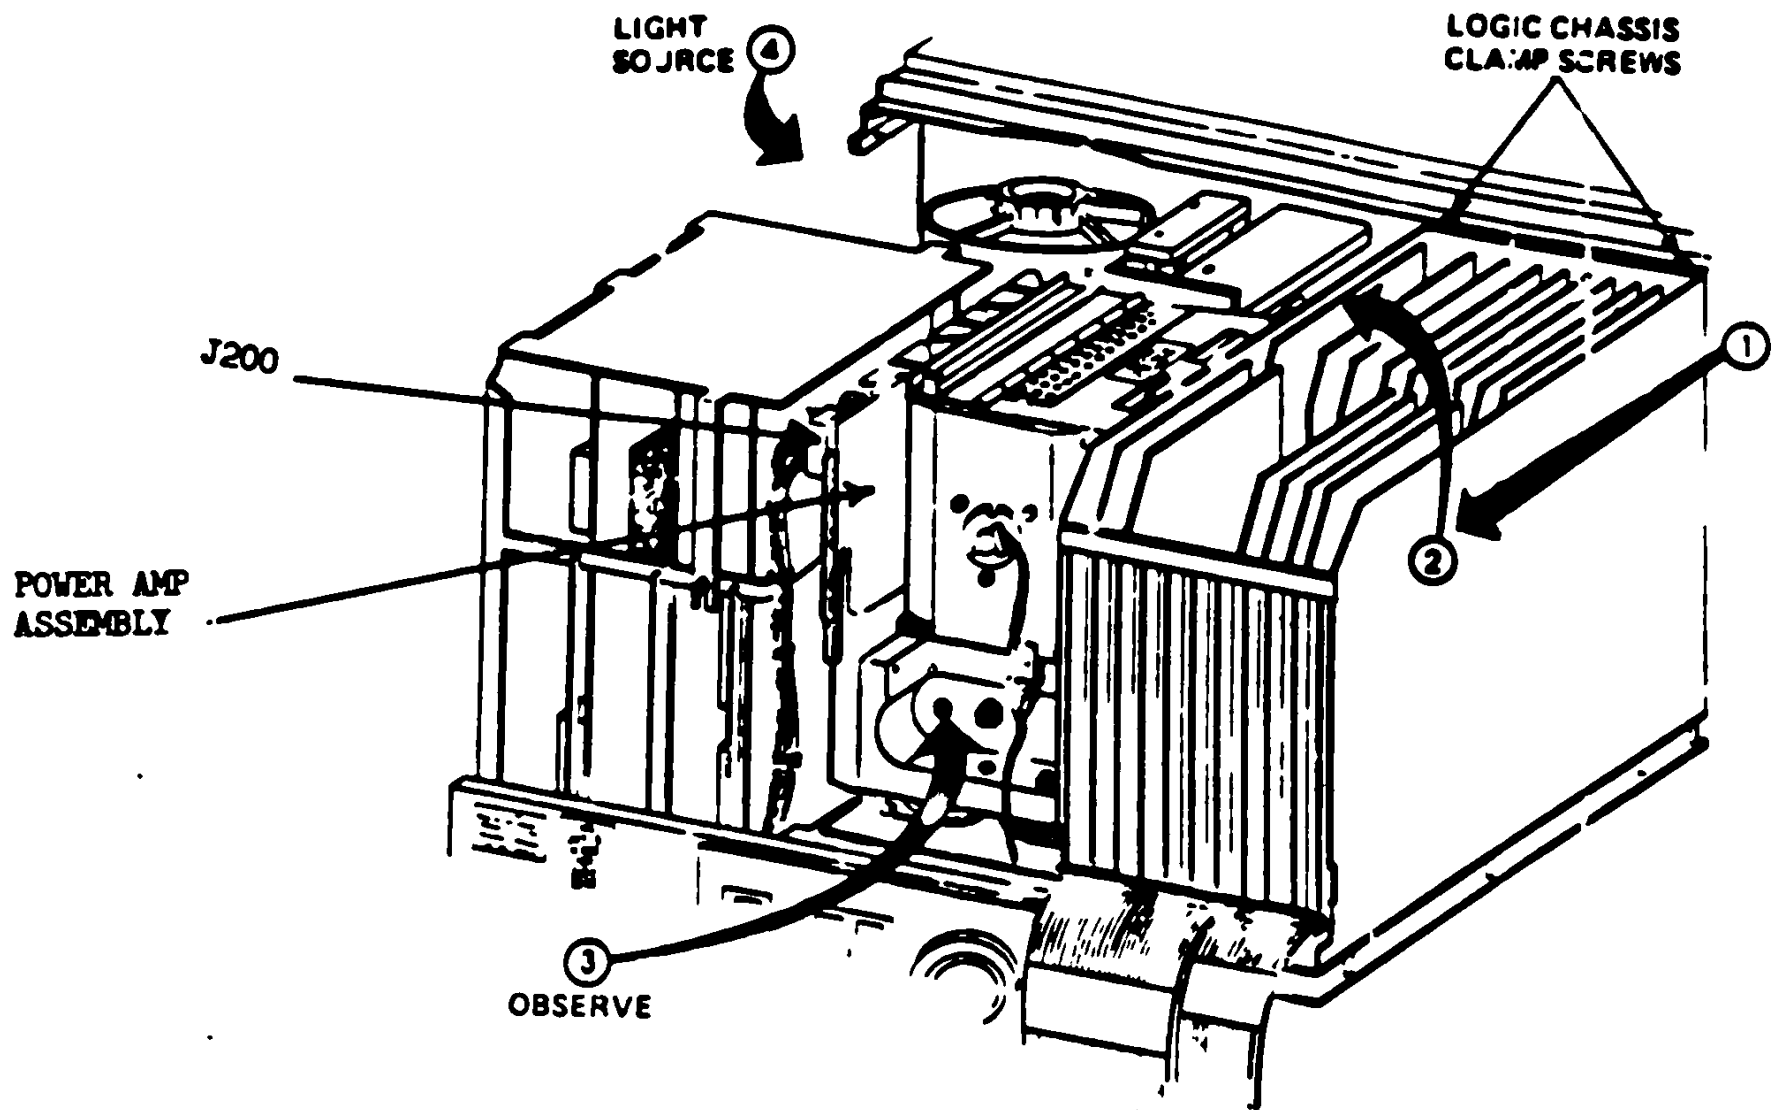
FIGURE 1

RM02-3 REAR VIEW

2. Remove the drive top cover assembly.
  - A. Loosen the two locking screws on the back of the top cover.
  - B. Slide the drive top cover back and then lift it off the rear of the drive.
3. Loosen the logic chassis clamp screws from the rear of the drive (See FIGURE 1).

4. Carefully slide the logic chassis (on its hinges) towards the rear of the drive and then up and to the left (counter clockwise) into the maintenance position (ARROWS 1 & 2 in FIGURE 1).

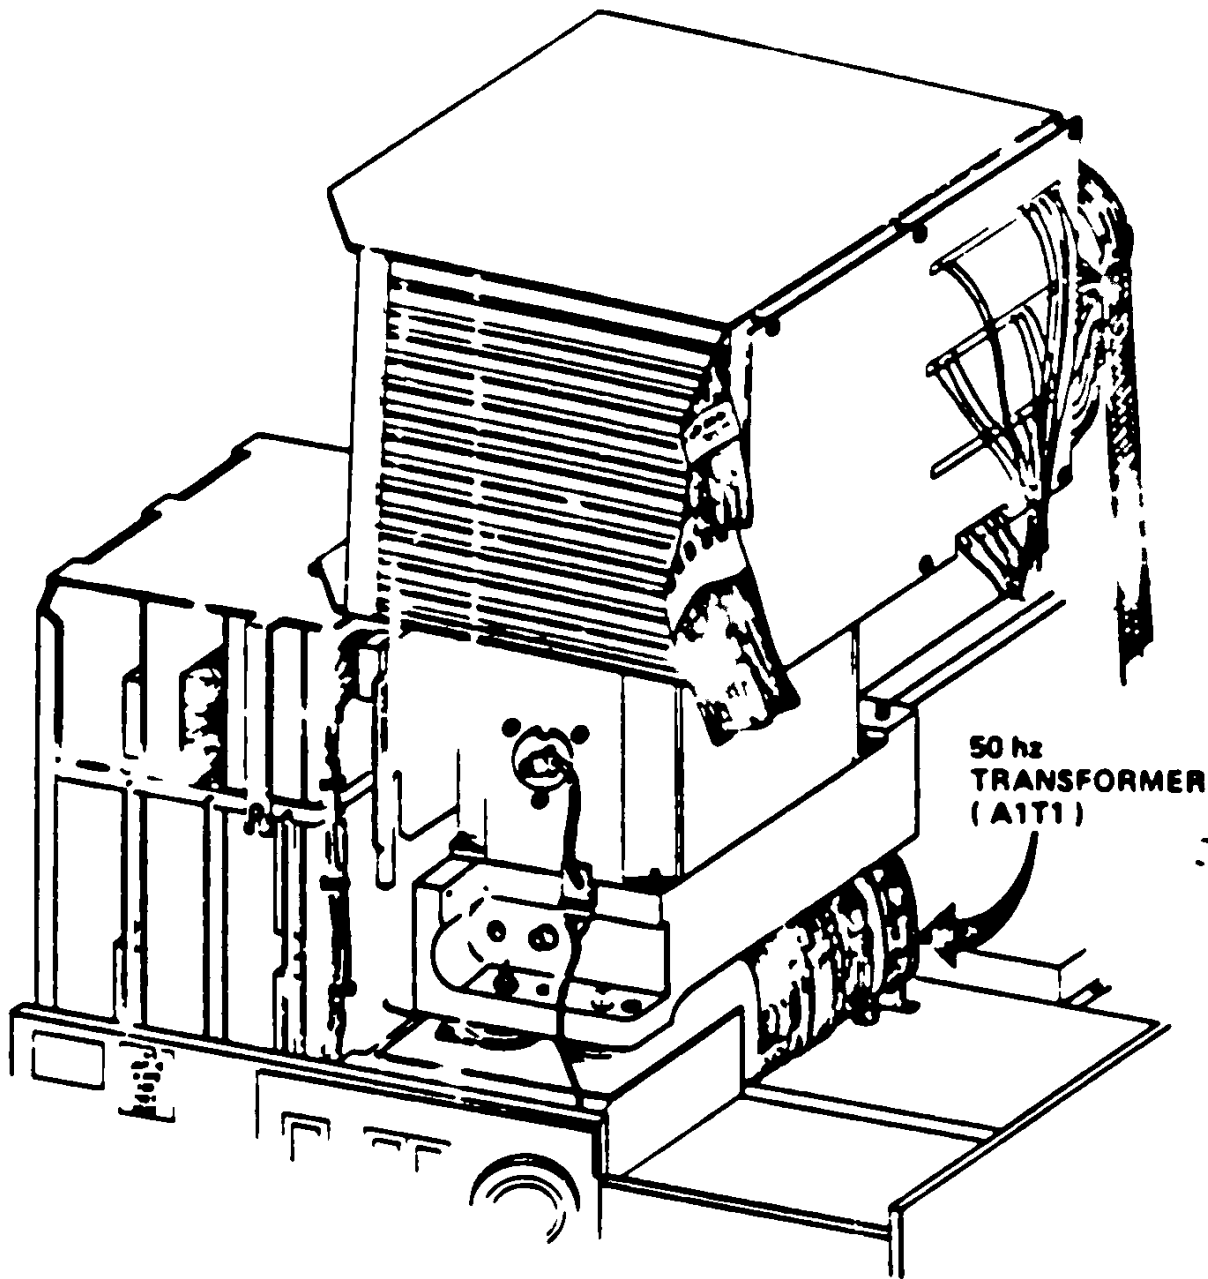
FIGURE 2

**Problem/Symptoms:** Transformer (A171) may come in contact with the upper deck plate assembly (when raised or lowered); resulting in damage to the transformer winding insulation and/or shorting of the transformer windings to the chassis.

5. Locate the main (50HZ) Transformer (A1T1) as shown in FIGURE 2.

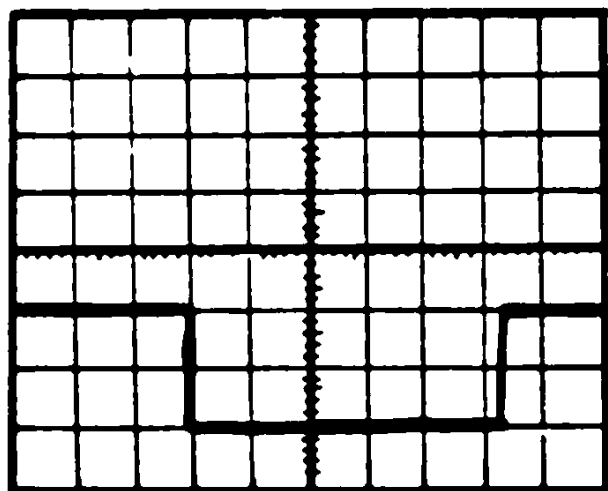
A2B02-03A

THE PICTURE SHOWN IN CHAPTER 4 OF THE RM02/03 DISK SUBSYSTEM SERVICE MANUAL (EK-RM023-SV-001) FOR THE VELOCITY GAIN ADJUSTMENT IS CORRECT. THE PROCEDURE IS CORRECT; HOWEVER, THE OSCILLOSCOPE DISPLAY COULD LOOK LIKE THE ONE BELOW IF YOU LOOKED AT TEST POINT B02-3A INSTEAD OF B09-3A.

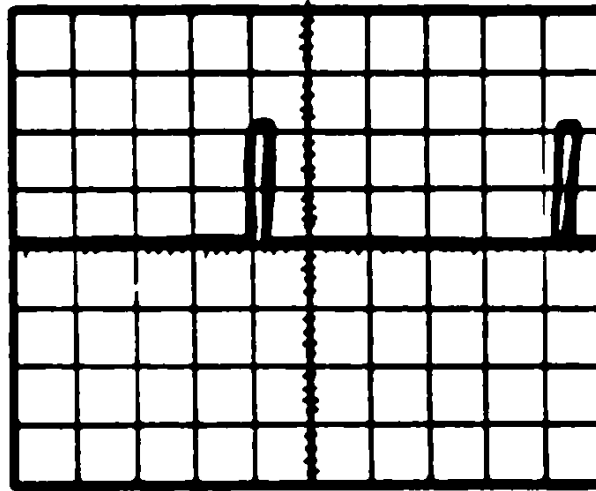
A2B09-03A CROSS REF PAGE 193 IS "+ ON CYLINDER"

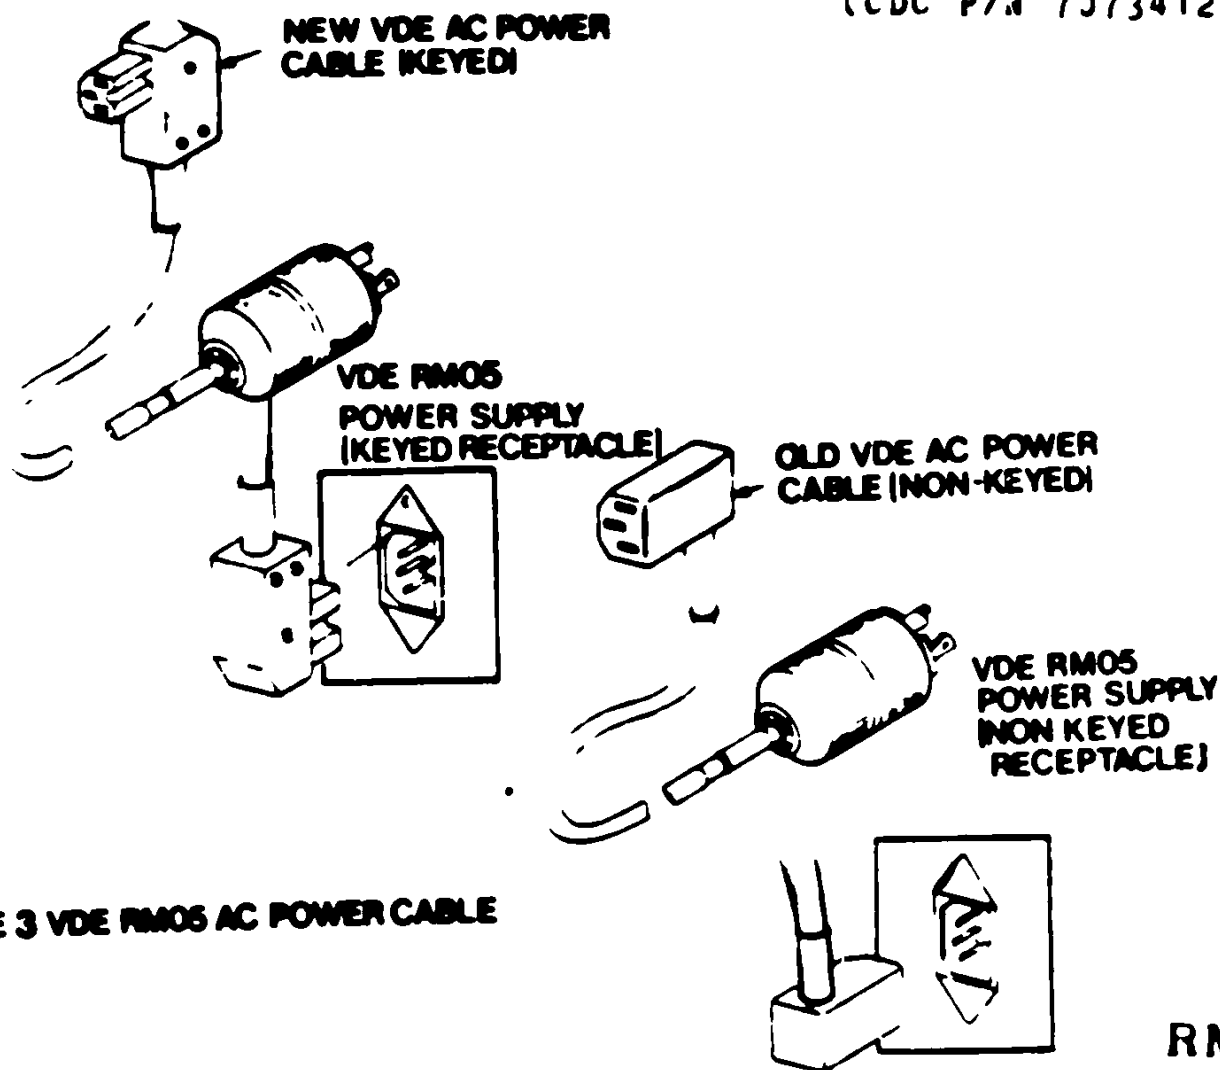
**FIGURE 3 VDE RM05 AC POWER CABLE**

The new AC power cables may be used with any of the VDF power supplies, but the old AC power cables will not fit into the new VDF power supplies with the vendor part numbers 73133108 and the above. An example of the new "keyed" cable is shown in Figure 3.

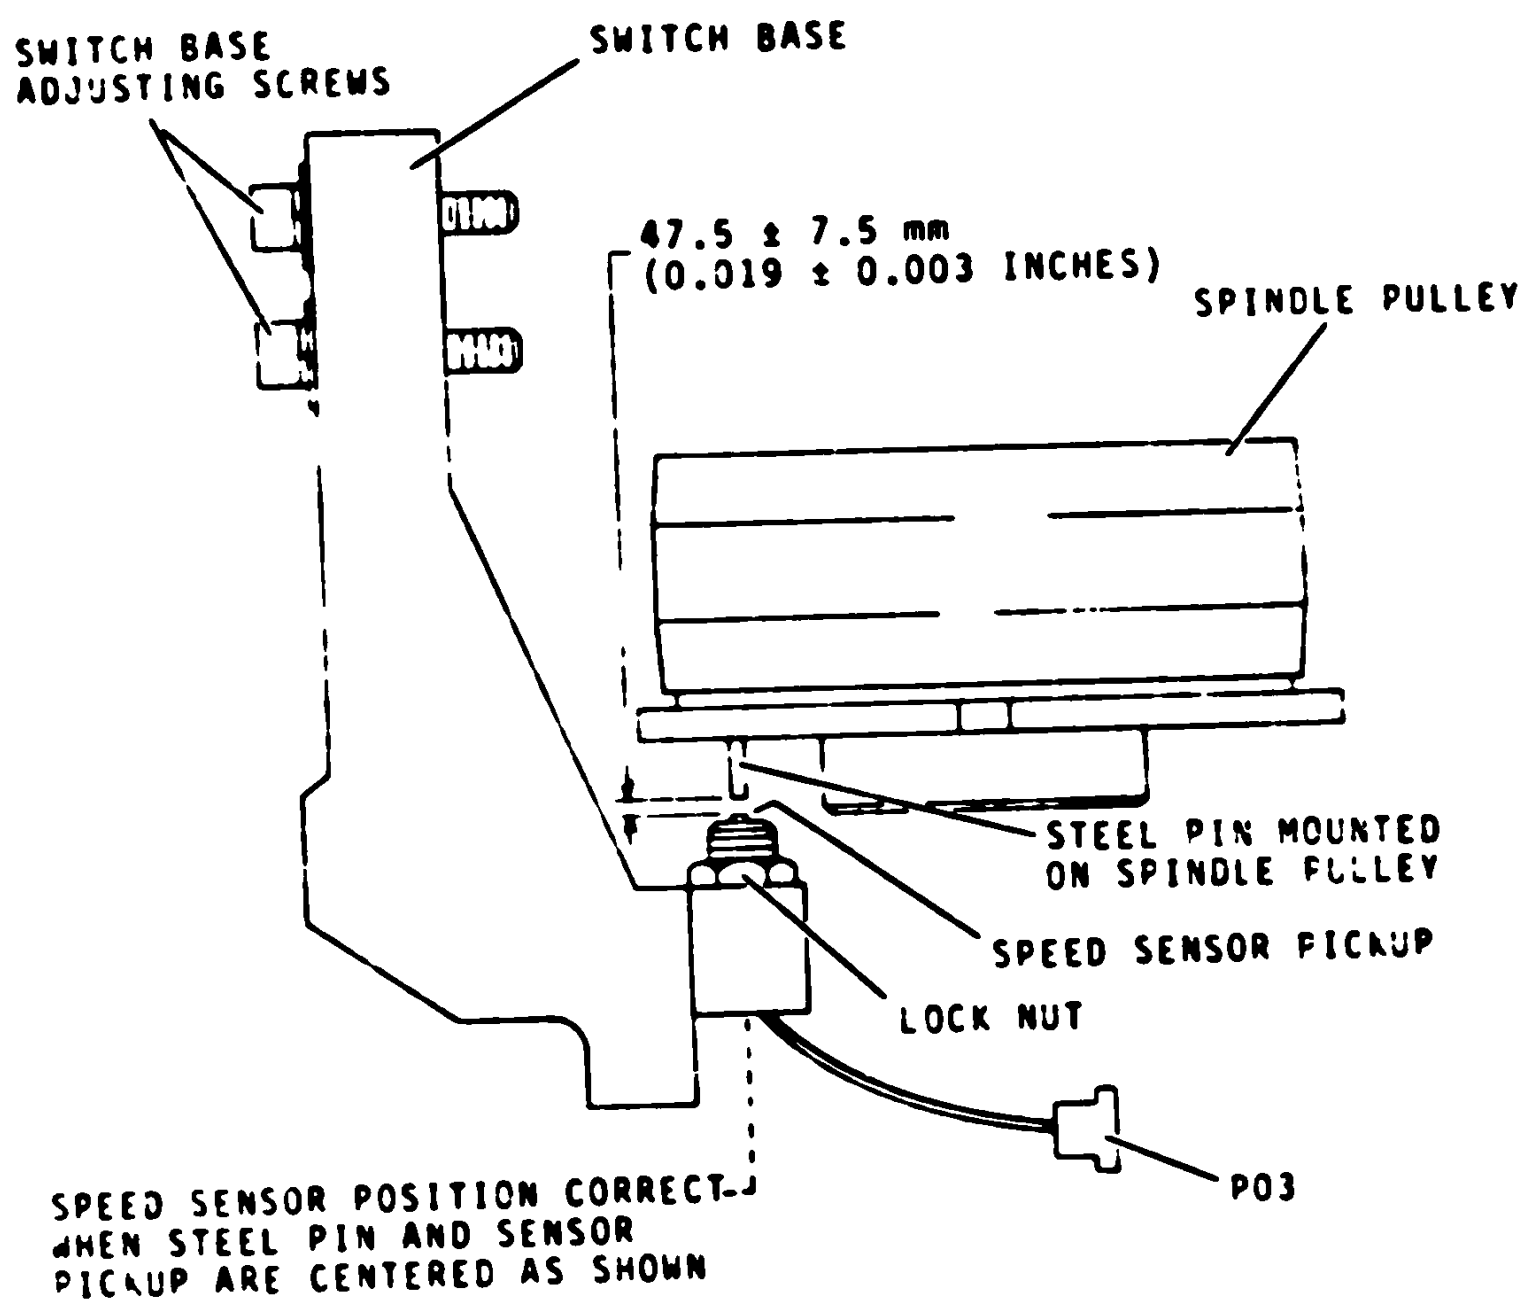
FIGURE 1 SENSOR ASSEMBLY ADJUSTMENT

This technical tip is to inform all field engineers of a possible hazard which may be encountered while doing a speed sensor assembly adjustment / replacement.

On the bottom of the spindle pulley is mounted a steel pin which passes over the speed sensor pickup. **NEVER** place a screwdriver, your finger, or any other object in this area while the spindle is turning. Doing so may cause damage to the spindle pin, speed sensor, or yourself.

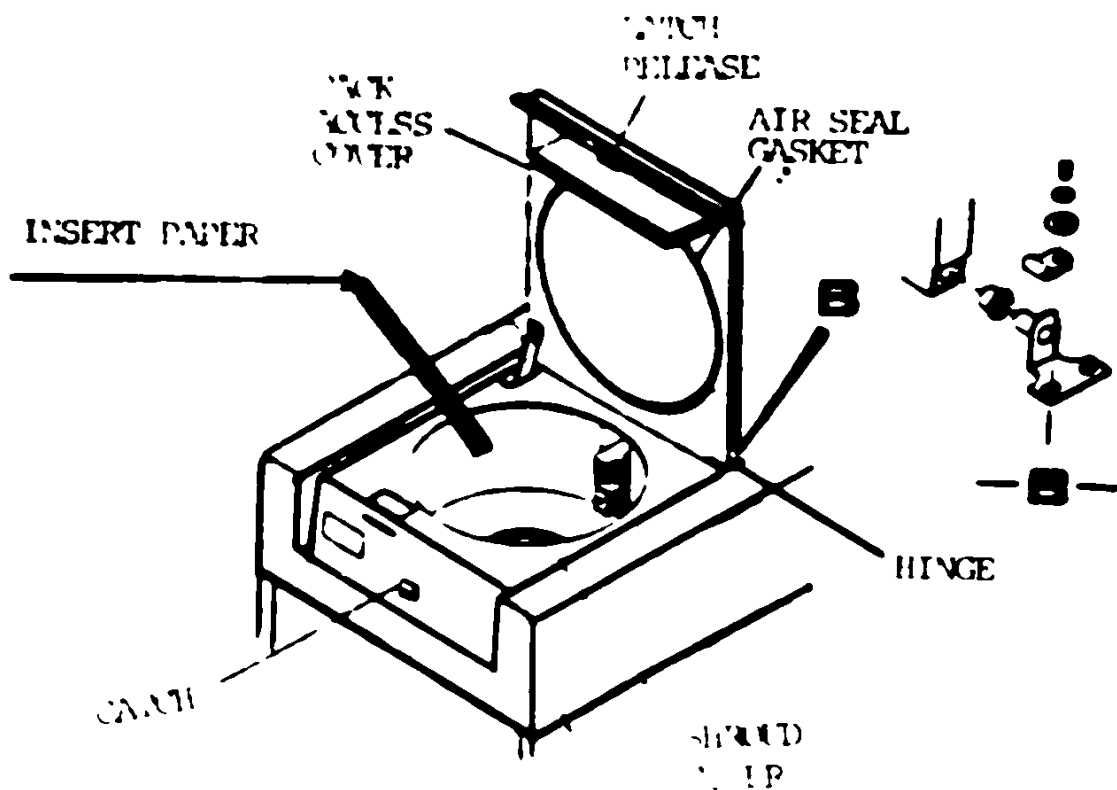
It has been found that a lot of head crashes can be attributed to air seal leaks. The following procedure should rectify this problem.

This can be checked by noting the drag on a sheet of paper as it is pulled out from between the closed pack access cover, and the shroud assembly. The amount of drag should be even around the seal. Adjust if necessary, by moving the front catch on the shroud up or down until the pack access cover latches tightly enough to provide an air tight seal. This adjusts the sides and front of the pack access cover.

NOTE: Because of the use of paper to check seal, you must purge pack for at least 15 minutes.

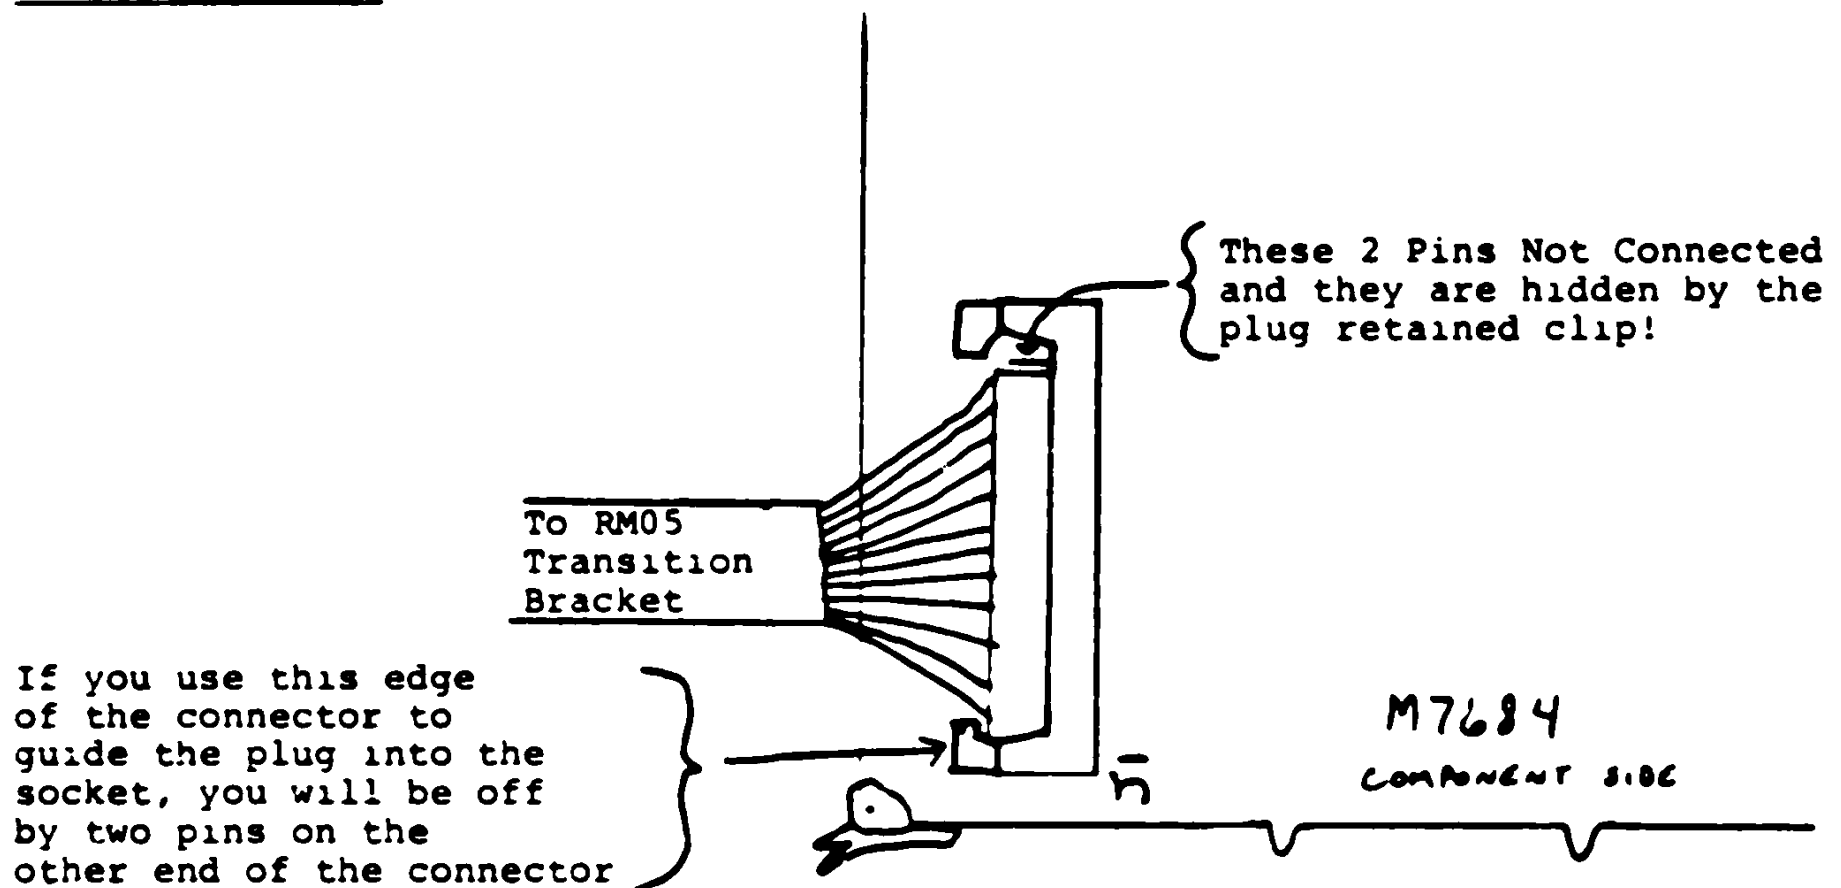
INCORRECT RESULT:

A problem exists between the AMP connector on the M7684 (J1) of the RM adapter, and its corresponding cable from the RM05 transition bracket. The problem is that the cable connector plug is narrower than the mating AMP socket on the M7684 (J1) board. This can result in the cable being plugged in two pins off. The proper connection of the cable is with all pins of J1 mated with the cable plug.

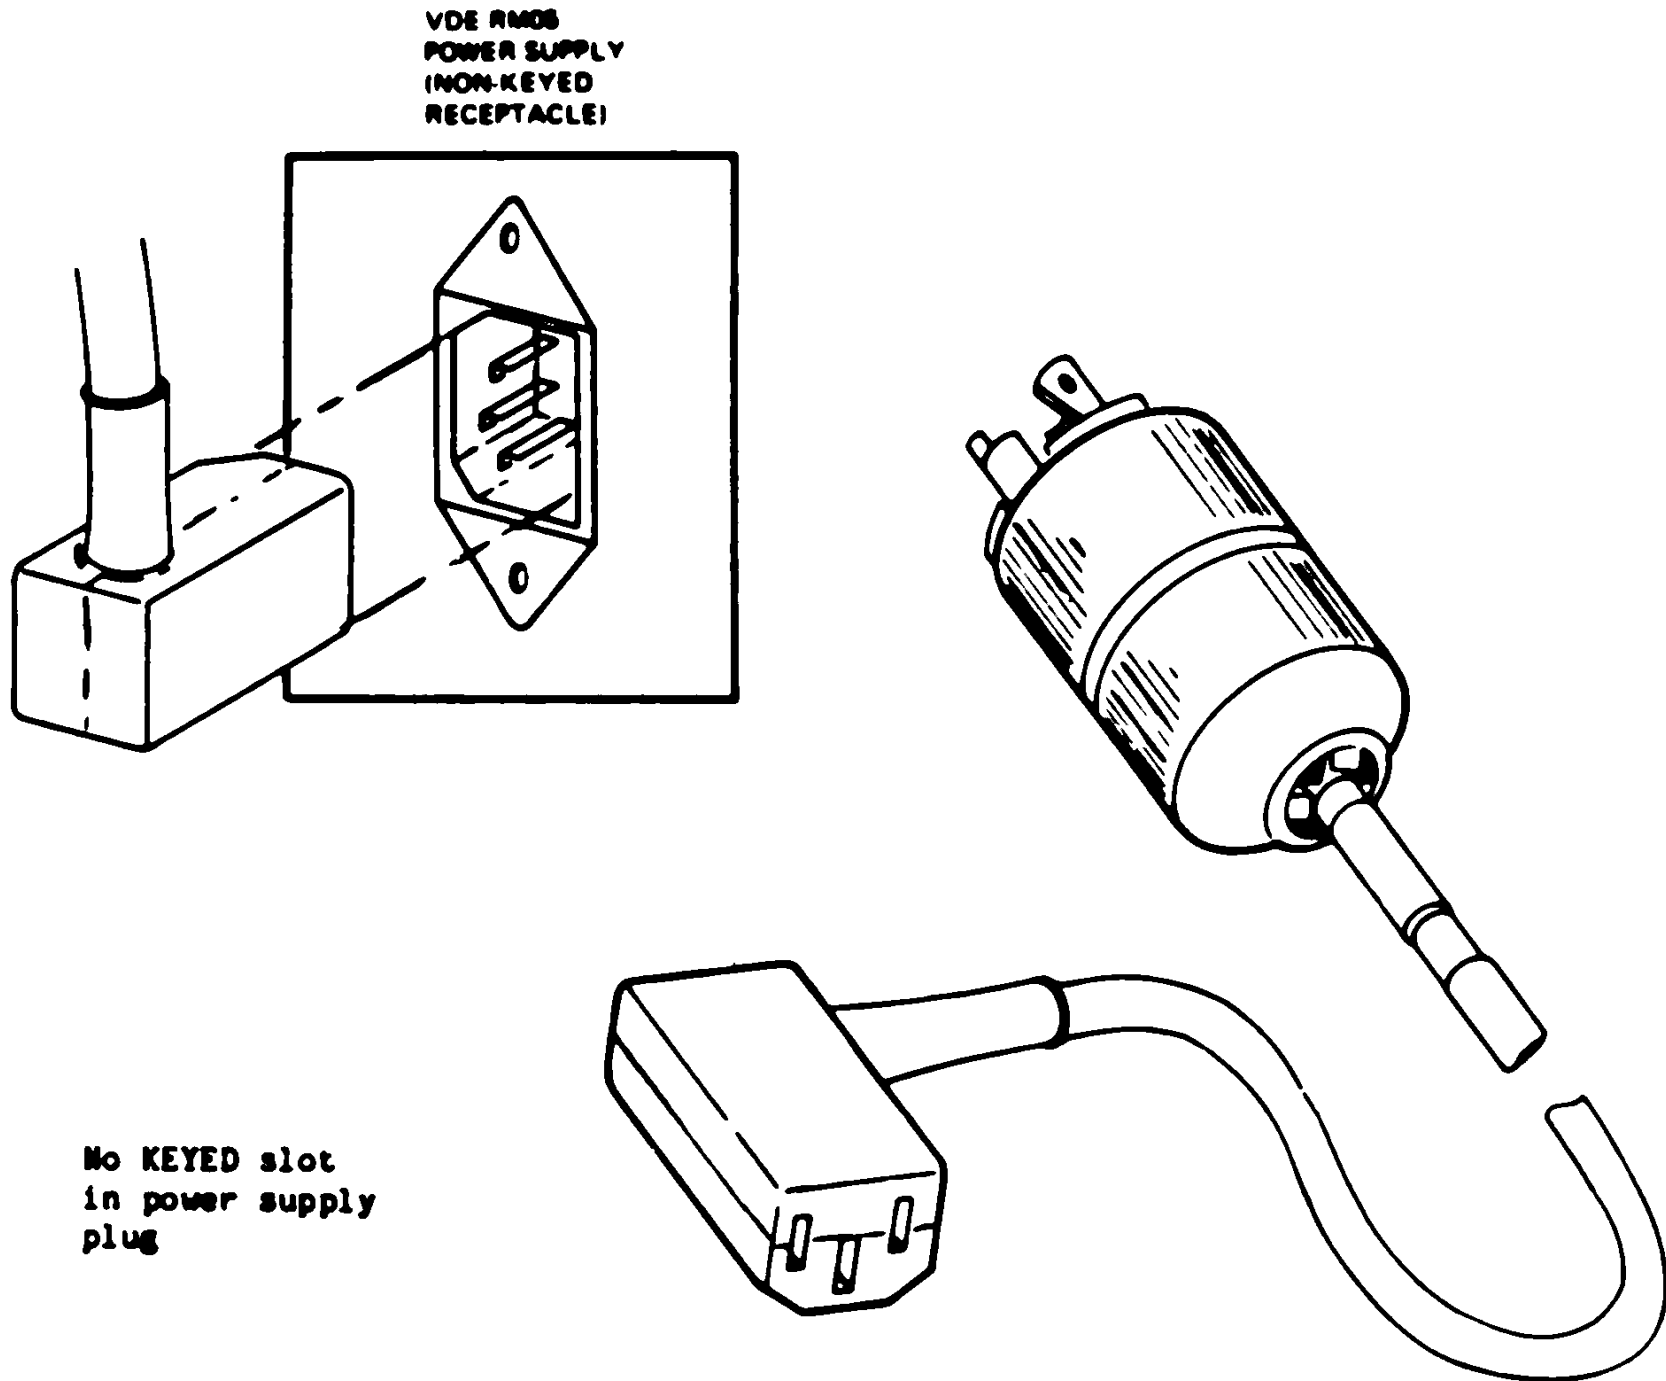
Figure 1. OLD Non-keyed AC Power Cord (VDE)

RM05 drives have started shipping with higher revision VDE power supplies using new "keyed" AC power cords to further meet VDE requirements. The new keyed power cords are compatible with ALL VDE power supplies. However, drives previously installed in the field may contain an earlier non-keyed AC power cords which WILL NOT FIT INTO the new VDE power supplies. Figure 1 and Figure 2 illustrate the physical differences between the keyed and non-keyed cables.
